## Owner Dies As Building Under Construction Collapses In Edo

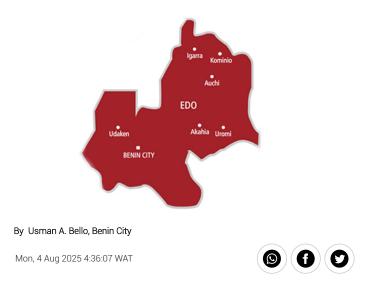
Sources said the one-storey building, intended to serve as a hotel, collapsed suddenly without any prior warning.

It was alleged that the collapse may have been caused by the use of substandard building materials.

A witness, who preferred to be anonymous, claimed that the owner had been cautioned about using low-quality materials, noting that 12mm rods were used for the pillars instead of the recommended 16mm.
