# Pastor dies in Benue church collapse

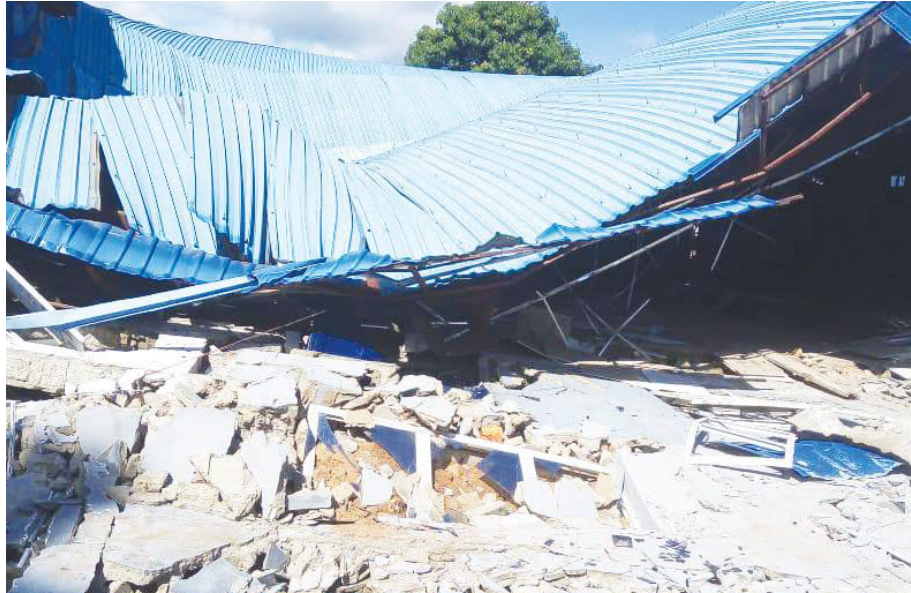
*Dunamis church, Makurdi*

It was while waiting that the church collapsed, killing the resident pastor, while others survived. A structural engineer, Peter Imbur, blamed the collapse on a structural error during the construction of the church.

Imbur said that the length of the church was about 25 metres long and 15 metres in width, while the entire building has no single pillar which was wrong and unacceptable.

The collapsed church building wall fell along the erosion path.
